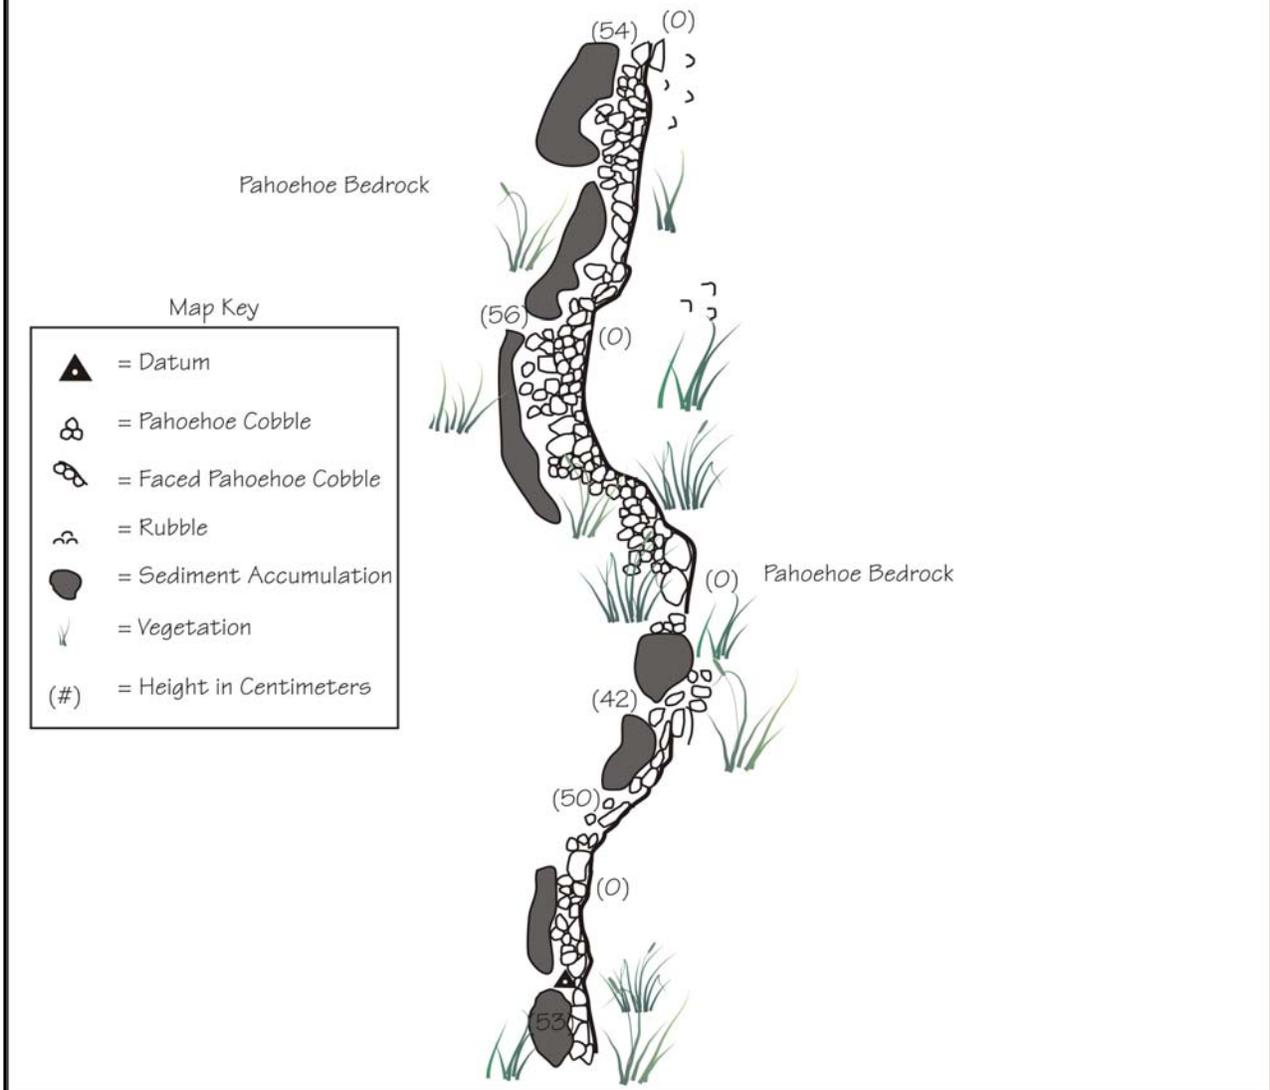
Figure 36. Feature HAVO-2005-D-33, Rock Wall

**HAVO-2005-D-33** (Feature 98-838) is a 17.1 m X 1 m X .59 m high wall constructed of stacked blocky pāhoehoe boulders built on top of pāhoehoe bedrock. The feature is along a NW/SE axis. The feature is not strictly linear or curvy, and wraps along the west side of a N/S running drainage. The east facing is constructed from large blocky pāhoehoe boulders that are stacked 2-4 rocks high to create a wall of uniform height. The feature surface consists of piled blocky pāhoehoe boulders creating an uneven choppy surface. The west side of the feature is not visible due to the vegetation and soil that has accumulated to the height of the wall. The vegetation of the area consists of *pūkiawe*, *a'ali'i*, ferns, grasses and the feature has been impacted by seismic, vegetation, weathering, and soil accumulation.

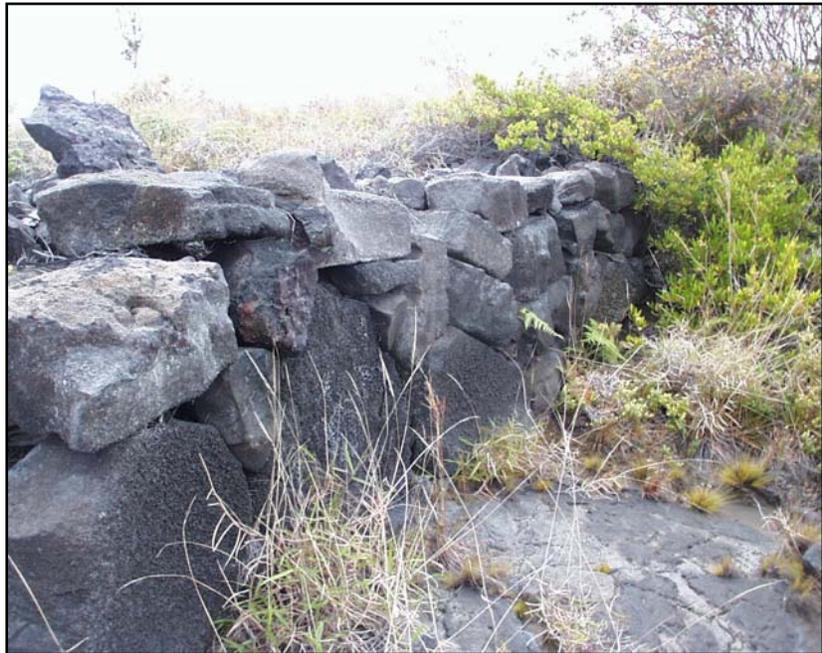
**Figure 37. HAVO-2005-D-43 Rock Wall**

**HAVO-2005-D-43** (Feature 98-855) is a 6.7 m X 3.1 m X 1.1 m high wall constructed of large pāhoehoe boulders and some cobbles. The feature is a wall located on the NW side of the drainage. It is constructed with nicely faced upright and stacked pāhoehoe boulders 2-4 courses high. There are several cobbles deposited within the drainage to both N and S of the wall as well as a few large boulders to the south. The vegetation of the area includes *a'ali'i*, *pūkiawe*, molasses grass, and other grasses. The impacts include flooding and vegetation and the feature is in excellent condition.

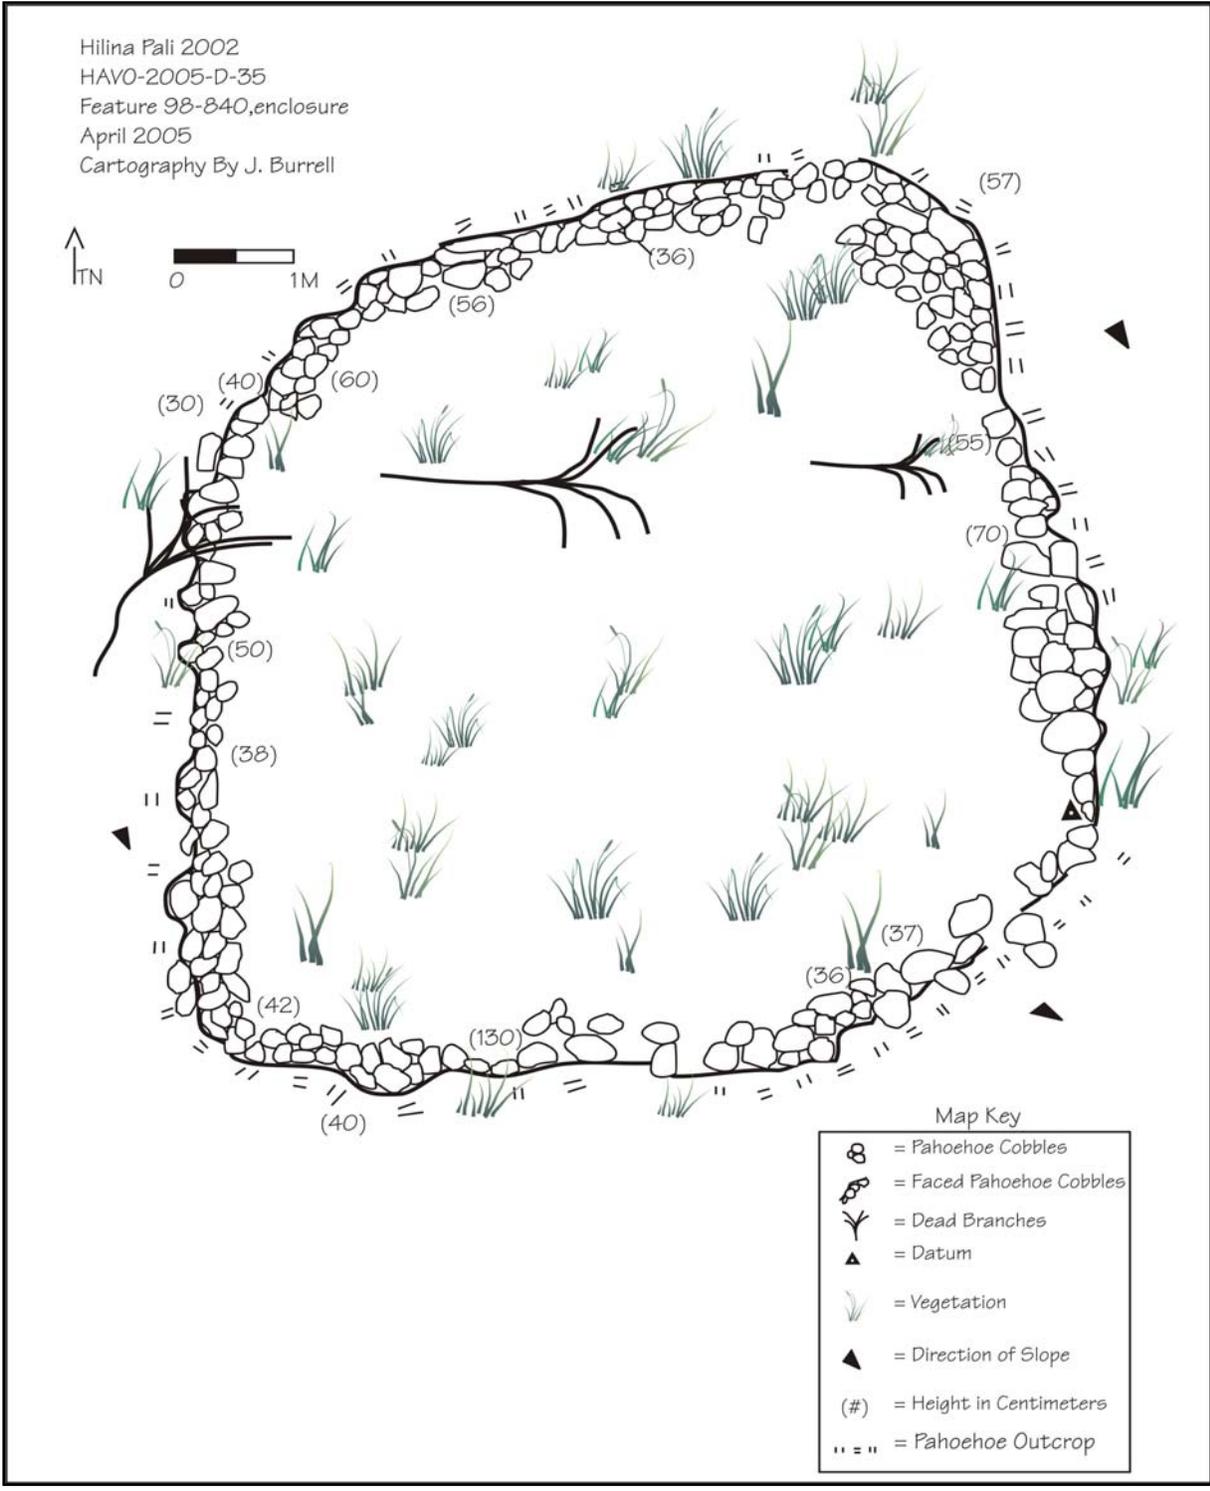
Figure 38. Feature HAVO-2005-D-35, Enclosure

**HAVO-2005-D-35** (Feature 98-840) is a 8 m X 7.5 m X 70 cm high enclosure constructed of porous basalt slabs located in the medial portion of drainage exterior. The feature is surrounded by a pāhoehoe outcrop and the interior is an ashy soil matrix. The feature is built around this natural contour and the slabs are laid upright along the exterior for height with the top having

both upright and flat lying slabs. The exterior and the interior portions are filled with mainly grasses with a few small shrubs, a few medium shrubs, and a couple of large trees. The wall to the south is lower with the drainage wall at a higher elevation. The stacking height is one to two rocks high and the vegetation consists of *a'ali'i*, grasses, and *pūkiawe*. The impacts on the site include weathering, seismic, and vegetation and it is in fair condition.

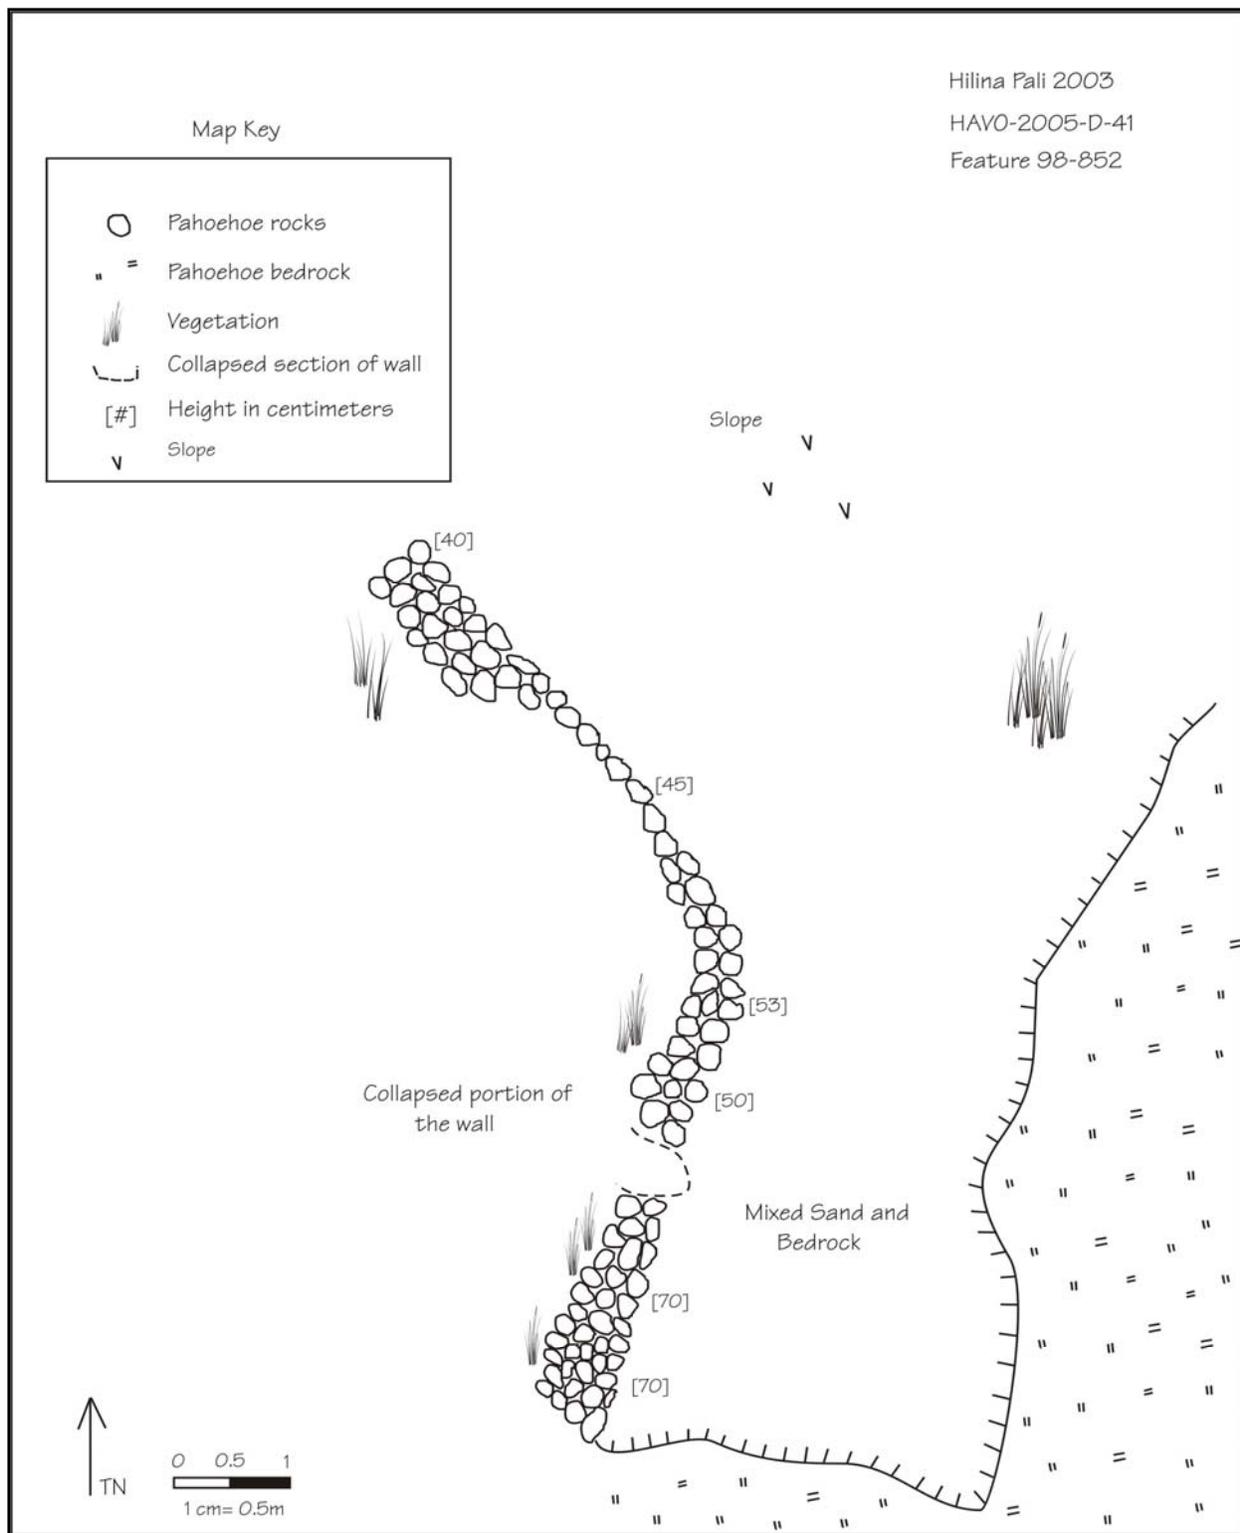
**Figure 39. Feature HAVO-2005-D-41, Rock Wall**

**HAVO-2005-D-41** (Feature 98-852) is a 15 m X 1 m X .8 m high wall constructed of pāhoehoe cobbles and boulders and dry stacked two to four courses high. The wall begins along the south side of a small tumulus and trends northeast to southwest and then curves to the south-southeast. This feature is vertically faced and in excellent condition. There is a fine soil/sand deposition all along the west side of the wall, which could indicate less

water flowing through this area. The feature could potentially be impacted by flooding and vegetation and is surrounded by *a'ali'i*, *pūkiawe*, broomsedge, molasses grass, as well as other grasses. The feature is in excellent condition.

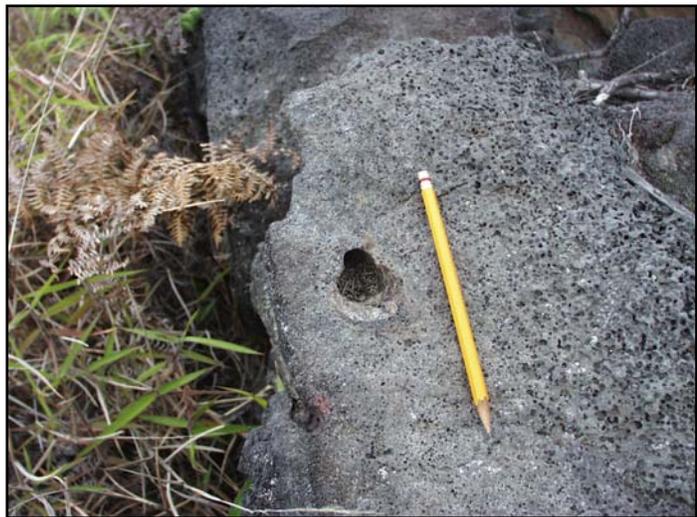
**Figure 41. HAVO-2005-D-44, Geologist Drill Hole**  
Photo Courtesy of the National Park Service

In the eastern part of the feature there is a hole that appears to be deliberately placed in one of the boulders along the side of the structure, in one of the pāhoehoe boulders on the west part of the structure, 10 cm long X 5 cm wide. The vegetation of the area consists of *pūkiawe*, *a'ali'i*, molasses grass, '*ōhi'a*', and ferns. The feature could potentially be impacted by erosion and vegetation. The feature is in good condition.

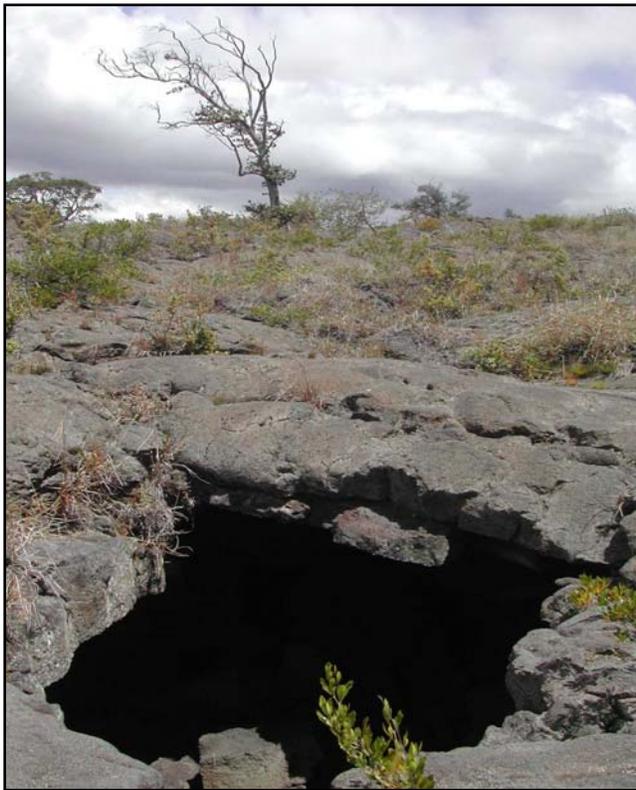
**Figure 44. HAVO-2005-D-53, Cave Entrance**

Other than the stacked rocks at the entrance the cave does not appear to have any cultural material inside. There is a large amount of soil deposited into the cave as well as mud and debris. The vegetation of the area consists of *pūkiawe* and the feature is in good condition.

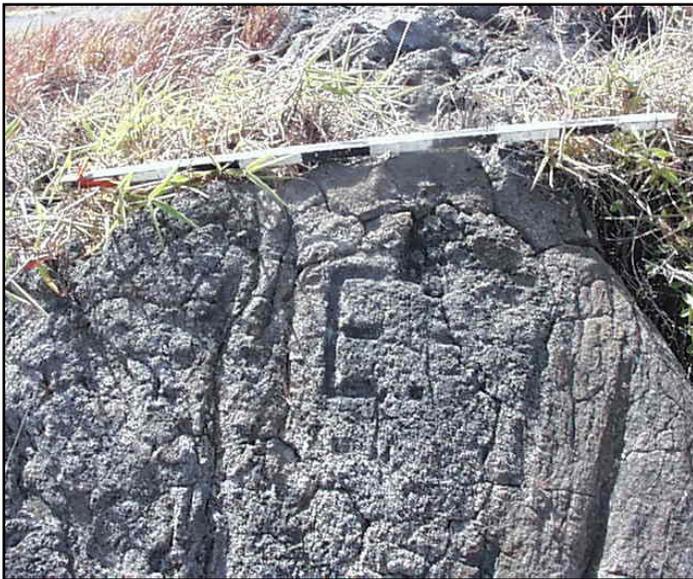
**Figure 46. HAVO-2005-D-54 Pecked  
Petroglyph**

**HAVO-2005-D-54** (Feature 98-877) is a 20 cm X 14 cm X 1-1.75 cm deep pecked petroglyph. The petroglyph was pecked into the W/NW face of a shallow tumulus. The tumulus face is weathered, cracked, and light brown in color. The pecked image looks like a letter "E" followed by a period. The petroglyph is deeply pecked with nice straight geometric lines and sharp corners. The area where the petroglyph is carved has some shallow natural cracks surrounding the feature, plus a small hole in the bedrock that is probably

natural. The petroglyph is located less than 10 m from the west of Hilina Pali Road. A shotgun shell was found at the south corner of tumulus, which is 1.2 cm in diameter.

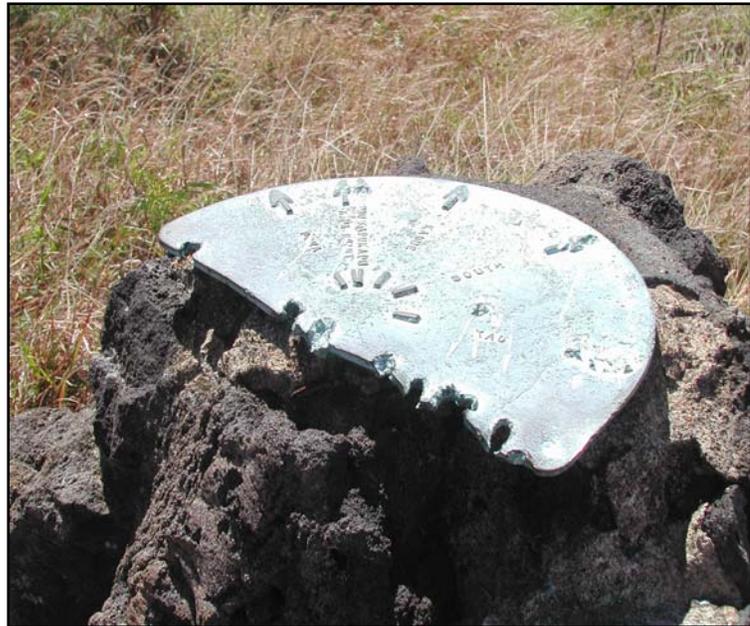
**Figure 47. HAVO-2005-D-57 Hilina Pali Pointer**

**HAVO-2005-D-57** (Feature 98-881) is a 1.2 m X 50 cm X 1.2 m in height Hilina Pali Information Pointer. This feature is made of mortared pāhoehoe boulders and some cobbles. The pointer is located off the end of Hilina Pali road approximately 50 m south of the shelter at the start of the trailheads. On the top of the information pointer there is a metal plate with arrows and names pointing towards Ka‘u, South, Kalue, Puu Pukapu, Apua Point and Puna. This feature is located on top of the pali overlooking the ocean. Seismic activity and fire are potentially impacting this feature. Vegetation surrounding this feature includes grasses, *koa*, *‘ōhi‘a* and guava. This feature is in excellent condition.

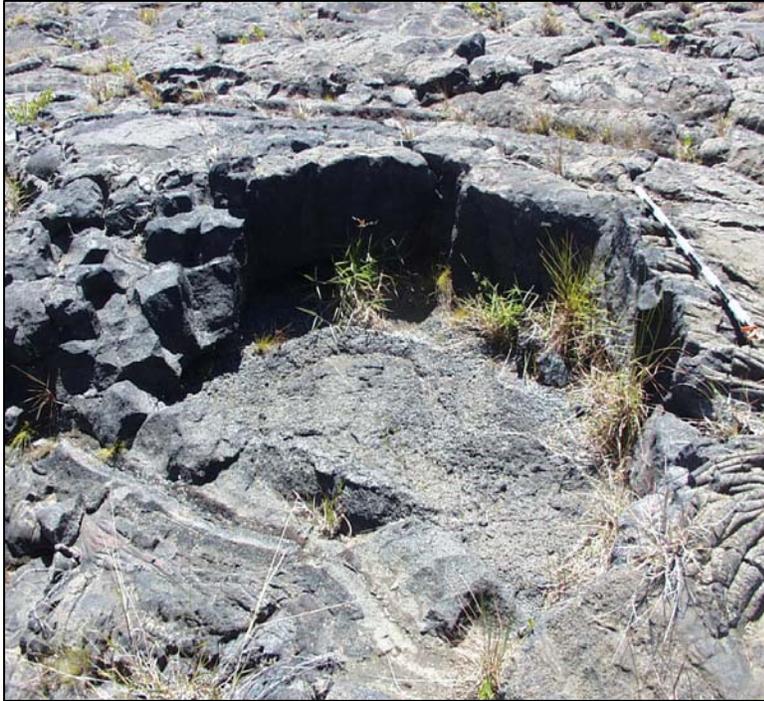
**Figure 51. HAVO-2005-D-72 Rock Quarry**  
Photo Courtesy of the National Park Service

**HAVO-2005-D-72** (Feature 02-21) is a 3.1 m x 1.9 m x 81 cm deep quarry. Feature is located 3 m west of feature 98-807 within the drainage. The edge is C-shaped and the SE section is quarried into a shelf. Impacts are floodwater, weathering, and vegetation. The vegetation includes molasses grass and *pūkiawe*. This feature is in excellent condition.

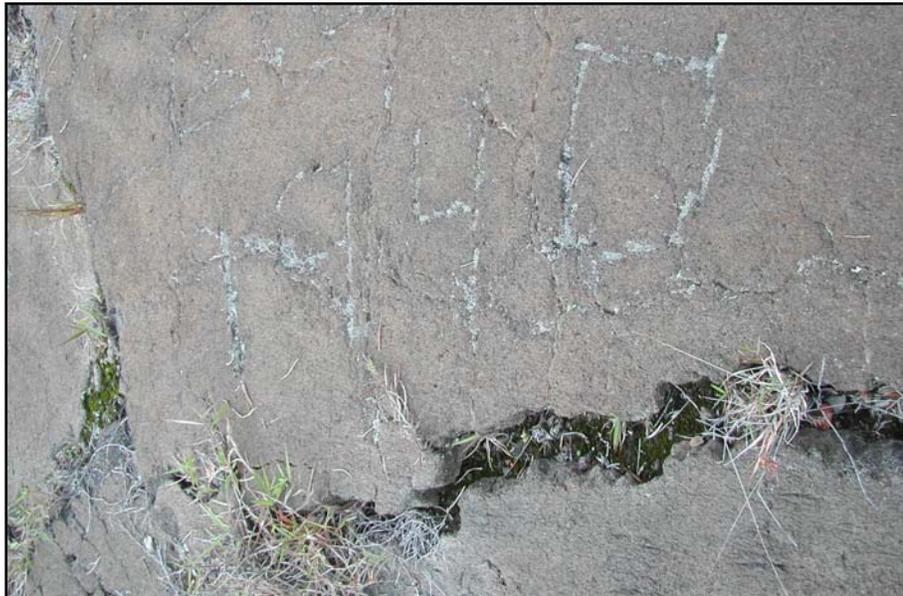
**Figure 60. Site Number 50-10-62-24525, HAVO-2005-D-112, "1940" Petroglyph**

**HAVO-2005- D-112** (Feature 03-17) is a 1.65 m X 1.3 m pecked petroglyph pecked on an open slab of pāhoehoe bedrock. The petroglyph is comprised of the letters "R.E.D. DENISON, CCC 1940". This petroglyph is found near another CCC petroglyph recorded in 03-12 and a lava tube recorded in 03-14. The feature is in an area vegetated by *pūkiawe*, *a‘ali‘i*, *‘ōhi‘a*, and grasses. It is in excellent condition.

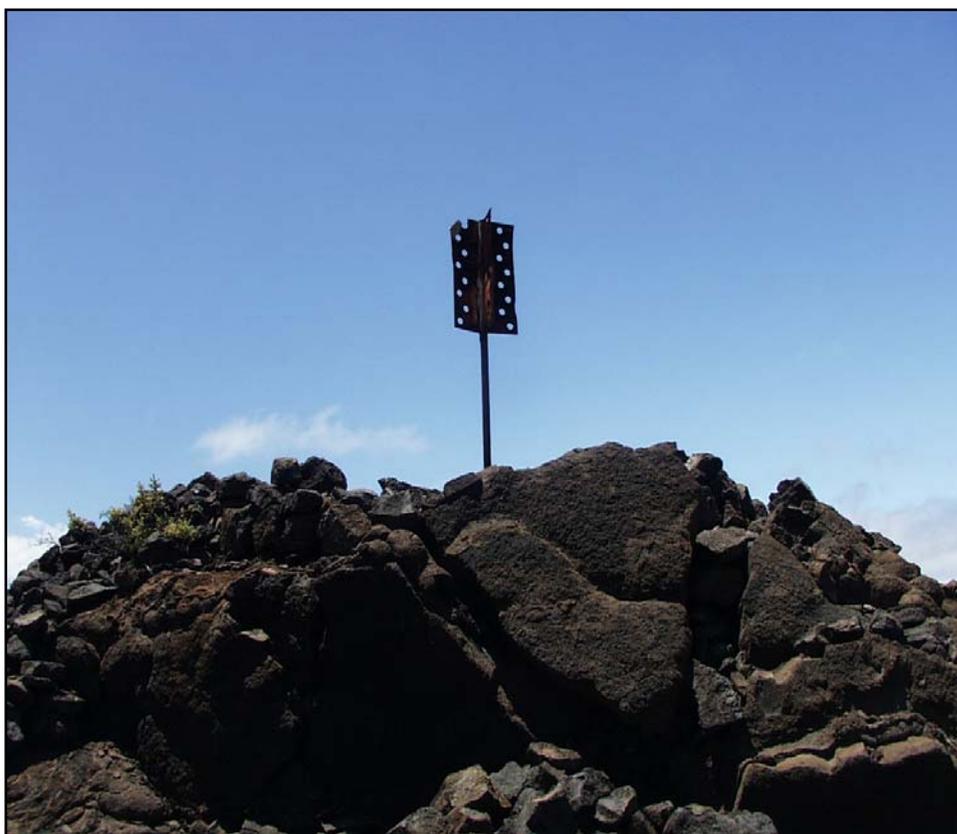
**Figure 65. HAVO-2005-D-125. Pu‘u Ohale.**

(Feature 98-40) is a 1.5 m wide X 4 m tall metal post and sign placed on top of a high pāhoehoe tumulus with 4 metal sheets sticking out of the top uniformly pointing in each direction. The marker, or flag is cemented into the top of the tumulus and surrounded by walls. In each metal sheet there is approximately 8 uniform holes. The metal is corroded and rusted. This site is named Pu‘u Ohale and, according to Don Swanson, was placed there by the Hawaiian Territorial Survey that took place in the early part of the 20<sup>th</sup> century. These surveys took place to mark boundaries as well as make topographic

maps. In the cement there are the words “Pu‘u Ohale” and “HTS 1938.” Around this feature there are many broken bottles and old rusted aluminum cans. There is a temporary shelter built around the tumulus which is described in feature HAVO-2005-D-128. Potential impacts to this feature include seismic activity, corrosion and human. Vegetation surrounding this feature include *pūkiawe*, *‘ōhi‘a* and *a‘ali‘i*. This feature is in good condition.

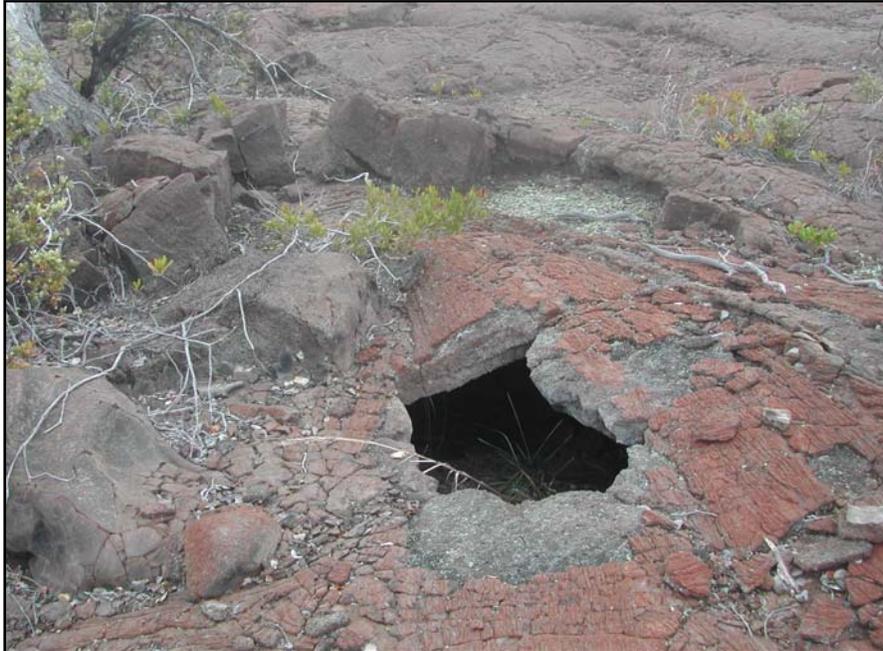
**Figure 68. HAVO-2005-D-126. Lava blister and possible temporary shelter**

**HAVO-2005-D-126** (Feature 98-66) is a 0.8 m long X 0.4 m wide X 0.4 m deep blister that formed from pāhoehoe lava flow. The opening in the flow is small and could have possibly been opened up more by human activity. It is a small blister but possibly big enough to fit someone inside that is lying down. Therefore it could function as a sleeping shelter. There are goat bones inside the blister and 15 m from blister there is a rock pile/ahu that is described in feature 98-54. Feature 98-66 could potentially be impacted by goats and erosion and is surrounded by *pūkiawe*, *‘ōhi‘a*, and *a‘ali‘i*. It is in good condition.
